NZIA CPD Presentation

Ecoglo Photoluminescent Solutions

NZBC F8 'Signs'

NZBC F6 'Visibility in Escape Routes'

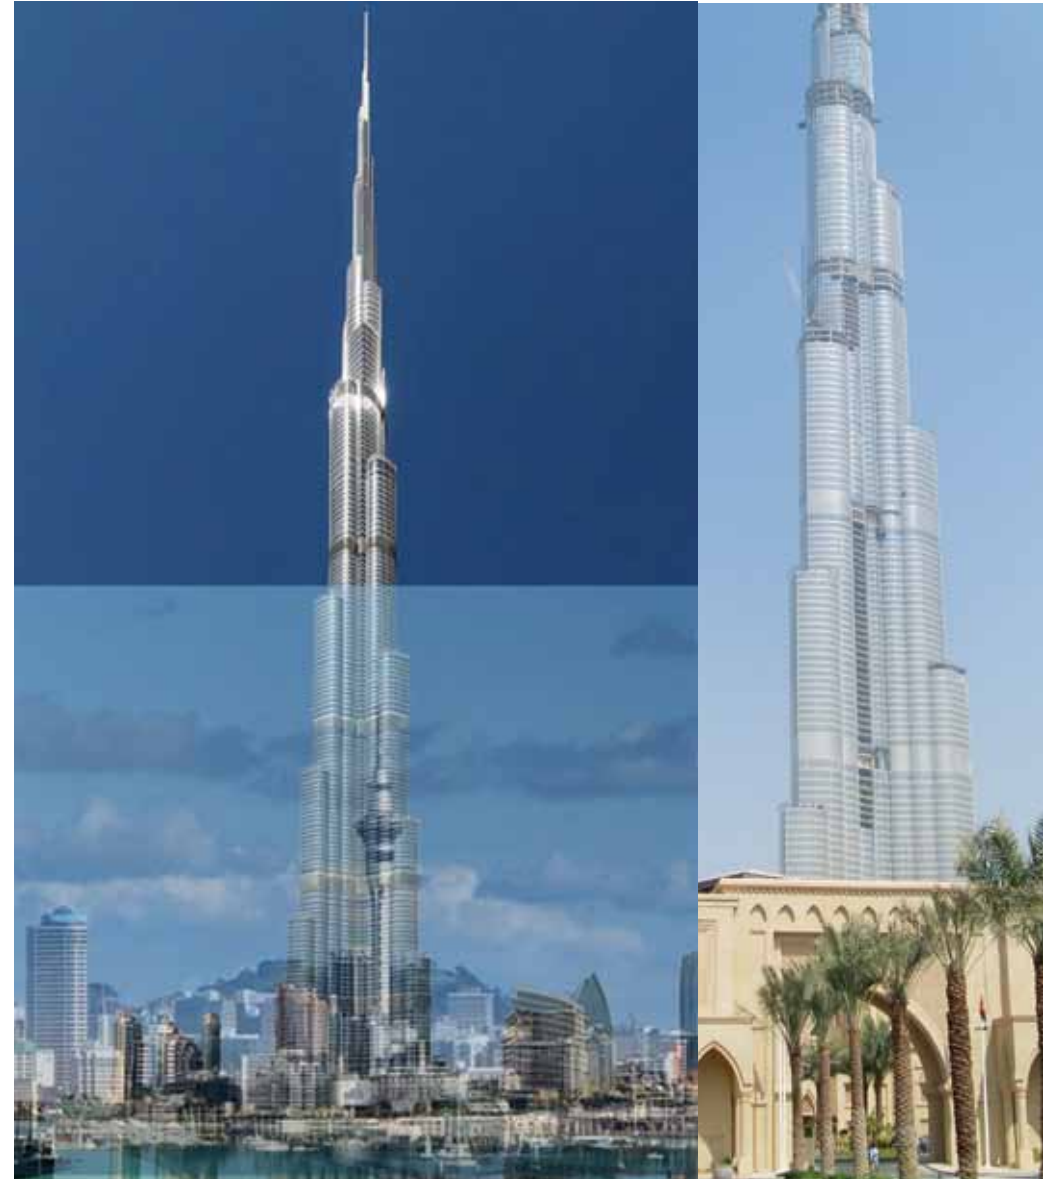
- Sydney Olympic Arena
- Time Warner Center (NYC)
- London Underground
- Burj Khalifa, Dubai (pictured)* – 12,000 steps
- Singapore Supreme Court
- St Louis Metro
- Wellington Hospital
- Royal Navy vessel refits
- Yamuna Sports Complex (New Delhi)

*The line shown indicates the height of the Auckland Sky Tower.

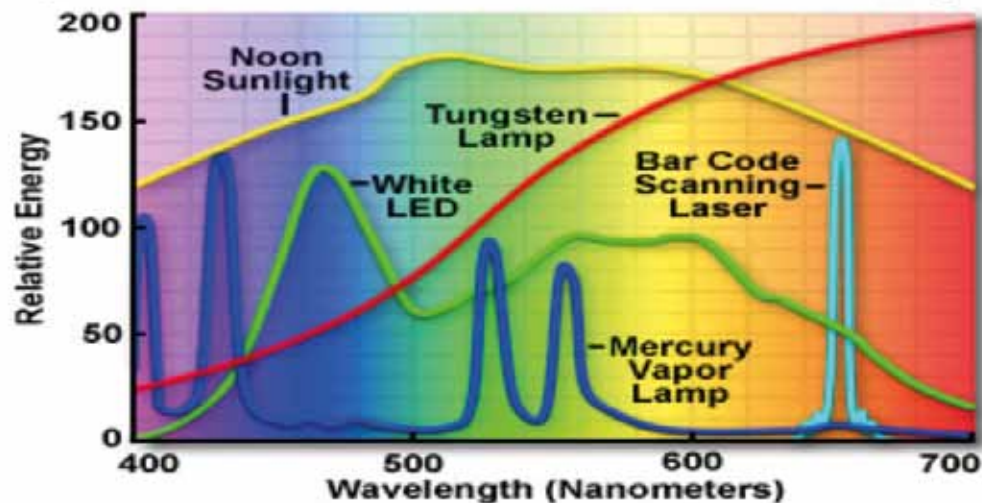
Spectra From Common Sources of Visible Light

White electric lamps are specified by colour temperature.

A low colour temperature (2700K-3500K) produces noticeably yellow light, often called 'warm white'.

A medium colour temperature (3500K-5000K) produces less yellow light, often called 'cool white'.

A high colour temperature (5000K-6500K) produces a non-yellow light, often called 'daylight' (the sun in the middle of the day provides light at around 6500K).

Low colour temperature lamps usually do not have as much emission in the 315-475nm range as medium and high colour temperature lights, so are not as good at charging PLM. Conversely, high colour temperature lamps are normally very good at charging PLM.

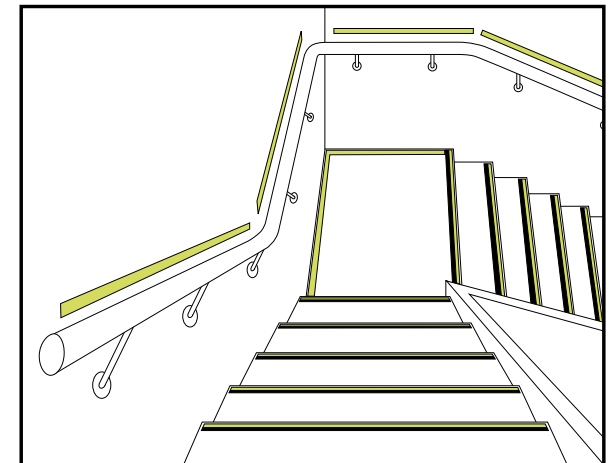
Example of stairway marked up for NZBC F6 compliance

Various PL products make ‘specified building features’ visible when the mains lighting fails.

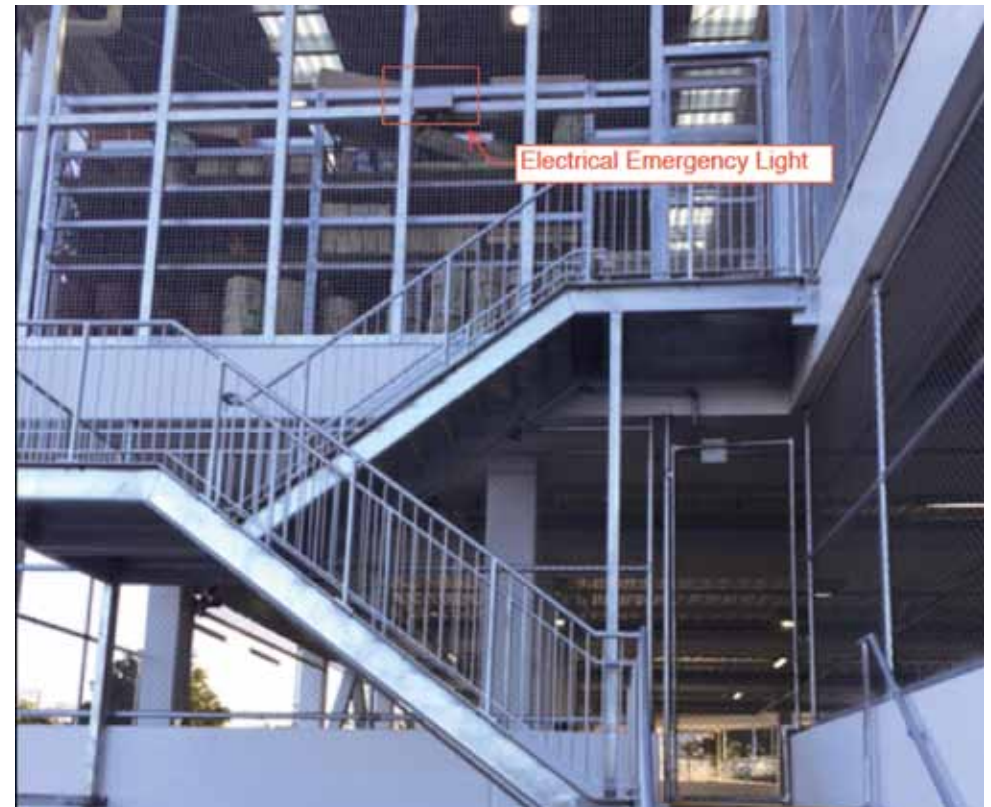
The image on this page illustrates that the installed outdoor electrical emergency lighting will not provide 1 lux on each change of level as required by the building code.

Cost disadvantages in comparison to a PL code compliant design:

- the initial capital cost of the twin spotlight unit
- the installation cost of the electrical wiring required for a separate emergency lighting circuit
- on-going maintenance costs of the lamps and battery

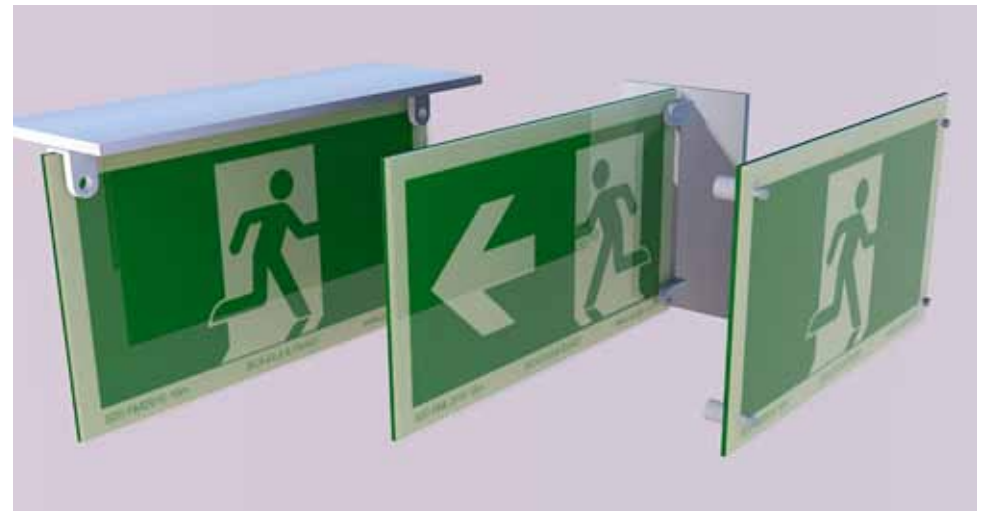
F6 & F8 Design Product Enhancements for 2016

- Custom architectural **black** step nosings
- Custom architectural **blue** photoluminescent strip
- Side and top **mounting brackets** for signs – enhancements on existing brackets
- **Hybrid signs** for areas that do not have the required lighting for charging a standard Ecoglo pl sign
